Technical in-dept Analysis for turbo 753420-5005S and 49173-07506 PSA 1.6HDi Applications

PSA 1.6HDi Applications

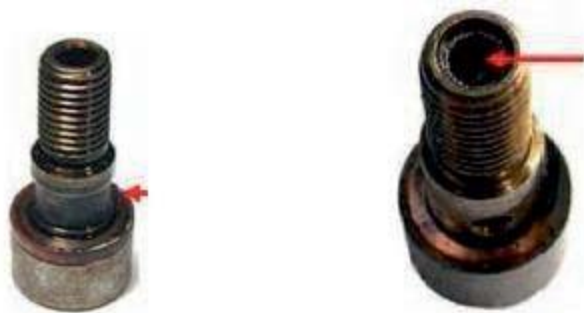
Since this engine was designed to operate at high temperatures, It is highly recommended the use of the absolute best lubricants and in order to keep its characteristics optimal, inside the turbo inlet oil pipe has been inserted a **filter and an integrated heat exchanger**.

However there is a **downside** to this; some cases indicate that if the engine has been operated with the **oil level below normal limits**, high concentrations of carbon in the oil may occur. This can lead to clogging of the filter in the inlet pipe, the oil exchanger and the main oil filter, which cause premature failure of the turbo.

- ***The oil inlet hose, fittings and filters on the fittings need to be replaced (See photo)***
- ***The oil pump and the peach connected to it should be removed and cleaned thoroughly***
- ***The oil exchanger and the filtering device must be removed and cleaned, check that the engine injector seals are not burnt or damaged and replace them***
- ***The oil flow should be checked as follows:***
 - Or place the turbo on the engine leaving the oil return hose disconnected.
 - Or install a longer oil return hose to control the oil flow into a separate container, start the engine and let it idle for 60 seconds, then turn off the engine.
 - Or measure the volume of oil in the container which should be at least 0.3 liters of oil.
 - Repeat the test two or three times to confirm correct oil flow.
 - Drive the vehicle for 40/50 km and replace the oil filter again.
